ACORN

Customer Service

Issue
2
May 1989

Page	Document Description	SID Ref.
1	News Bulletin	CSN0006
2	Master Series 128 internal MODEM connector	CSN0007
3	Philips Monitor Field Service	CSN0008
9	Appendix	
	Service News-letter November 1988 introduction	
	Archimedes series Field Change Orders overview	
	Archimedes series Field Change Order FCO2002	FCO2002
	Archimedes series Field Change Order FCO2003	FCO2003
	Archimedes series FCO Service Report example

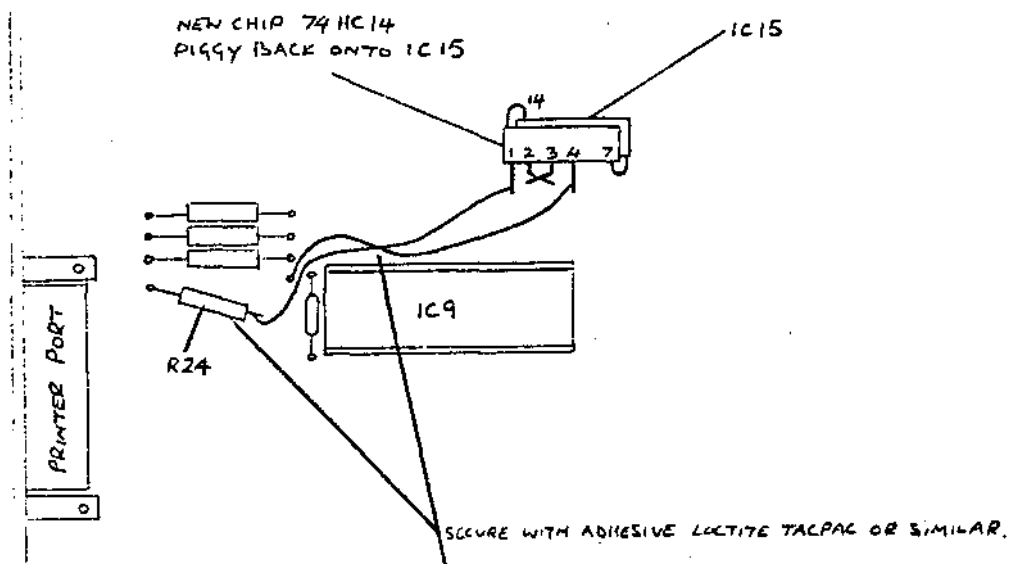
FCO 2002 Parallel Printer Port

Timing problems with printer control lines have led to spurious operation of some printers. This has proved particularly noticeable when using Integrex colour printers in graphic mode while line feeding - a spurious line feed being generated.

- 1) Remove the circuit board from the computer.
- 2) Refer to diagram 1, and identify R24. Cut the leg of R24 closest to IC9, and carefully move the free end of R24 away from the adjacent resistor. Secure R24 to the PCB with adhesive (for example Loctite TAC PAC), leaving the free end of R24 available for soldering.

- 3) Prepare new IC (74HC14) by:
 - a) Removing pins 5,6,8,9,10,11,12 and 13
 - b) Lift pins 1 and 4 ready to solder leads
 - c) Lift pins 2 and 3, and solder them together

- 4) Position new IC onto IC15 piggyback fashion so that pin 1 of the new IC is directly above pin 1 of IC15. Solder pins 7 and 14 of the new IC to pins 7 and 14 of IC15.

- 5) Solder thin insulated lead from pin 1 of the new IC to the free end of R24. Solder a second insulated lead from pin 4 of the new IC to the vacated pad of R24. Keep these leads as short as possible, and secure them to the new PCB with adhesive.
