Engineering Support Application

*Number: 297**Issue: 1.00*

## Hardware Modification and Testing Procedures to enhance StrongARM / PC Card compatibility

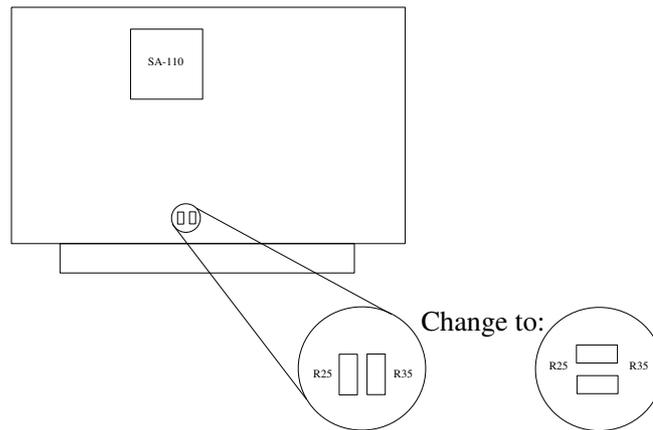
*Figure 1: Location and configurations of R25 and R35 on the StrongARM Card*

If the system appears to be unstable on the RISC OS side if and only if a StrongARM is fitted, typically failing with data aborts on startup or shortly after booting, a hardware modification may be made to the StrongARM card to improve its timing synchronisation with the rest of the system.

Our findings have shown us that this problem arises more frequently on Issue 1 and Issue 2 motherboards (those originally fitted with RISC OS 3.50 and which do not have 16 bit sound on the motherboard) than with Issue 3 boards; in any case, less than 5% of motherboards appear to be affected in this way.

What this change actually does is insert one more ACT08 gate in the path of the MCLK signal from the CPU card connector to the SA-110; this causes MCLK as seen by the StrongARM to be delayed by 4ns relative to the pre-modification MCLK. This delay is best thought of as a phase skew on MCLK as propagated to StrongARM in order to more closely align the rising edge of NCLK with the stable data area on the data bus.

Locate resistors R25 and R35 on the CPU side of the StrongARM card. They should be mounted with their long axes perpendicular to the main connector on the card. Desolder them, and re-mount them on the same set of four pads with their main axes parallel to the card's main connector. As R25 and R35 have the same value, it is not important which resistor is mounted above which in the new arrangement. The unmodified and modified arrangements are illustrated in the figure below.

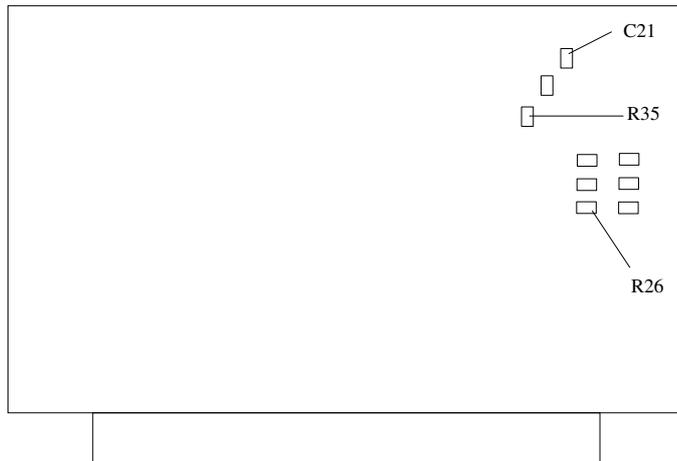
Figure 2: Location of C21, R26 and R35 on PC Card

Following their initial release, it was found that some Gemini 2 PC cards could fail on boot-up from cold when partnered with highly-clocked ARM processors, especially when fitted to machines which had been significantly expanded in terms of RAM and podules; it was also possible for cards to hang an unpredictable and irreproducible time after booting. A small number of component changes were cut into production shortly after this was discovered, and so most PC cards today have already had these modifications made.

R35 changes from 560R to 680R

C21 changes from 22pF to 0R0

R26 changes from 0R0 to 56R
