SIMTEC ELECTRONICS

Fitting the upgrade kit to A3020 and A4000 Computers

Check Your A3020 Serial Number!

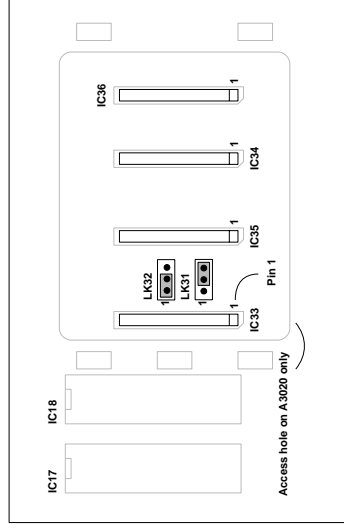
Follow the instructions in Appendix E 'Inside the computer' in the Welcome Guide to gain access to the memory upgrade sockets. For the A3020, do not worry if you find that your computer is not fitted with a metal cover. The memory devices are inserted into the sockets marked IC33, IC35, IC34 and IC36 making sure that they are the right way round. Move the cap on LK31 to position 2,3 and move the cap on LK32 to position 1-2. Follow the Welcome Guide to reassemble the computer.
