SECTION 3 Additional Upgrades

64K SIDEWAYS RAM DAUGHTER BOARD FITTING INSTRUCTIONS

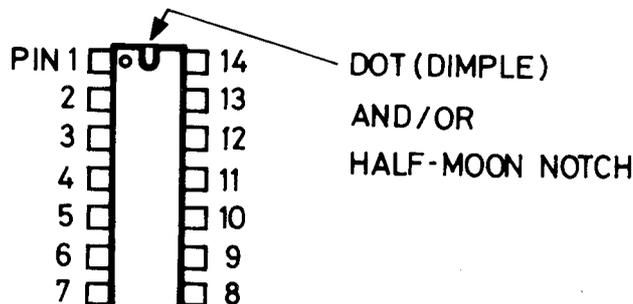
Figure 1

The numbering sequence for a 14 pin device is shown in fig.1. As can be seen pin 1 is at the NORTH WEST corner, all the other pins are numbered consecutively in an anti-clockwise direction.

With two exceptions, all ICs on the main PCB face NORTH, with pin one being located at the NORTH WEST corner of the chip. Pin one is indicated in one of two ways. Either a small dot or dimple is placed directly next to pin 1, or a half-moon shaped notch is cut into the pin 1 end of the IC, with pin 1 always being to the left of the notch when the notch is held uppermost. In some instances both of these indicators will be present.

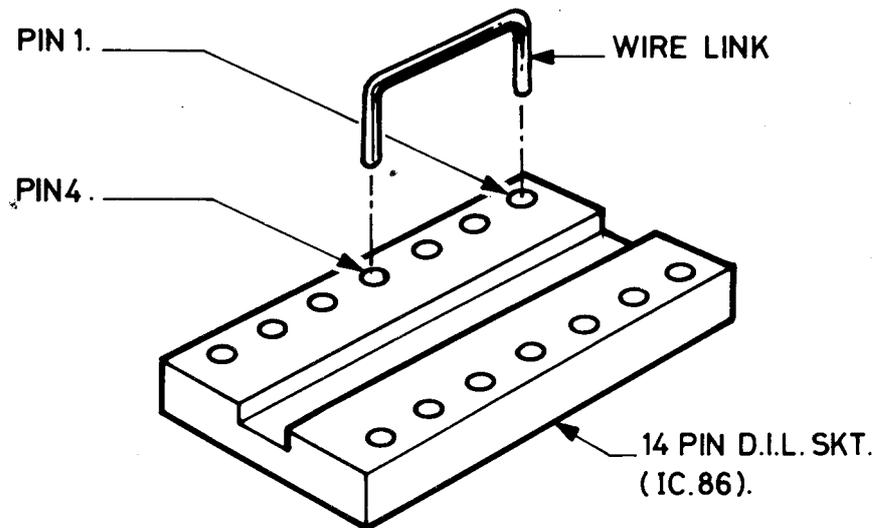
Figure 2

Fit one of the wire links provided with the upgrade kit into socket IC86 connecting between pin 1 and pin 4 (see fig.2).

Locate position IC87. If this position is occupied by a 74LS123, the second link supplied with the upgrade should be disregarded. If the 74LS123 is not present the second link should be fitted between pins 9 and 12.

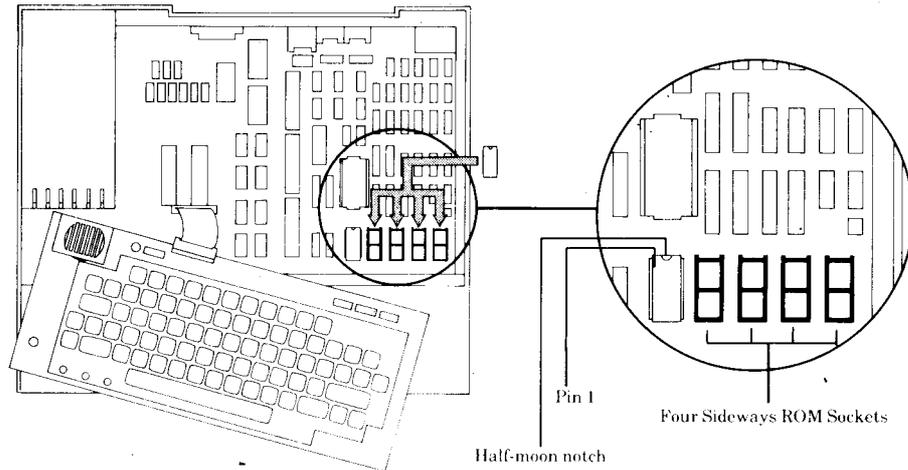
Figure 3

The filing system ROMs are located at the SOUTH EAST corner of the main PCB as shown in fig.3.

This diagram shows a plan view of the BBC Microcomputer Model B. The top of the computer casing has been removed to reveal the four sideways ROM sockets. ROM software may be inserted in any of these sockets.

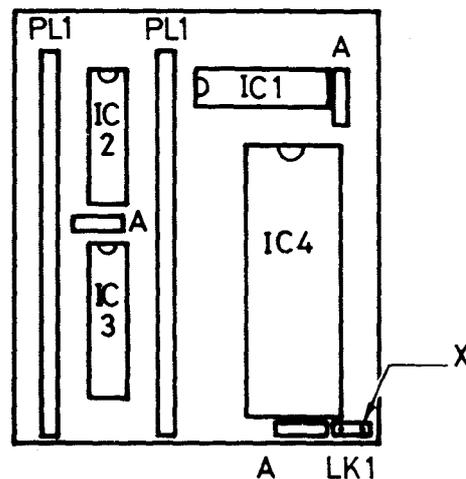
Figure 4

2. Remove the PCB as detailed in section 8.1. Locate and cut LK1 on the 1770 module. Using a piece of insulated wire, connect the pad of LK1 (indicated with an 'X' in fig.4), to the plate through hole directly to the NORTH of pin 1 of IC86 (see assembly diagram on inside back cover).
