# RISC OS 3 software upgrade fitting instructions: Errata

## Incorrect diagrams

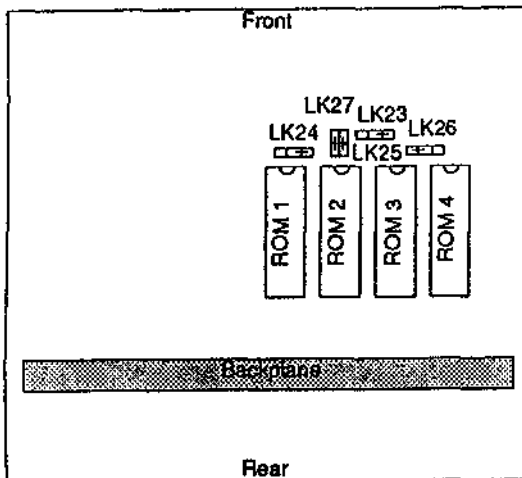
Archimedes 540 and Acorn R260 computers

This is the correct diagram for page 20:

Please note that the diagrams on pages 20 and 32 are incorrect, showing the ROMs the wrong way round, although the text does describe the correct way to fit the ROMs. The correct diagrams are included below.

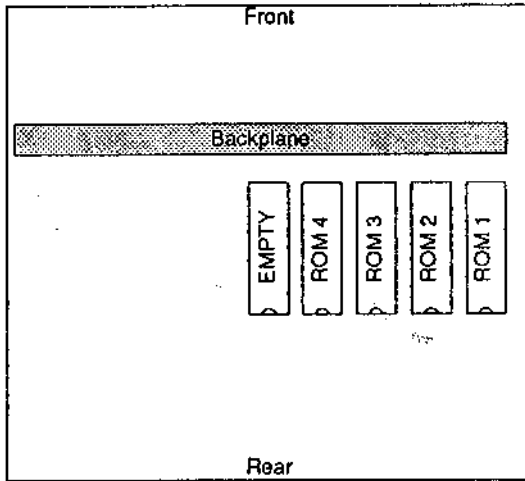
Acorn A5000 computer

This is the correct diagram for page 32:
